### Laboratory of Places 2018

**Presentation Group 2**

Summer School: Surveying Cultural Heritage

#### Chapel number III: «First fall of Jesus»

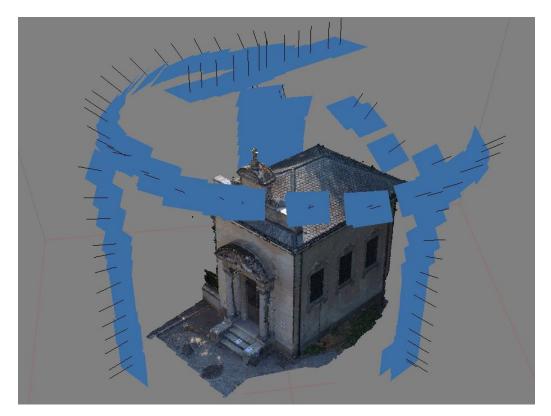
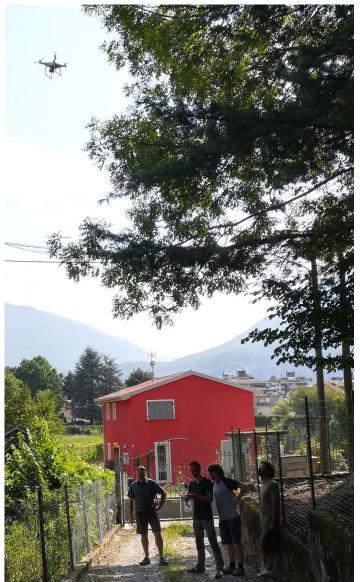
#### **STEP 2: Drone Photos**

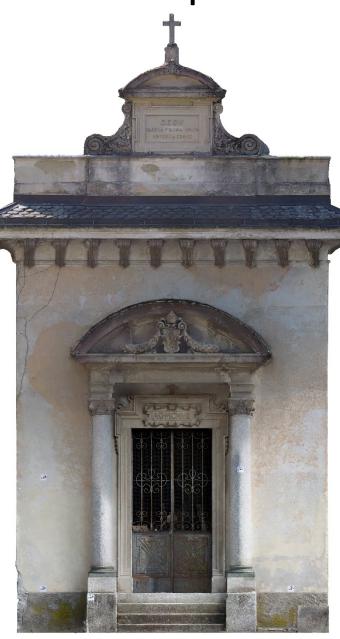
**Main Facade**

#### **STEP 3: Orthophotos**

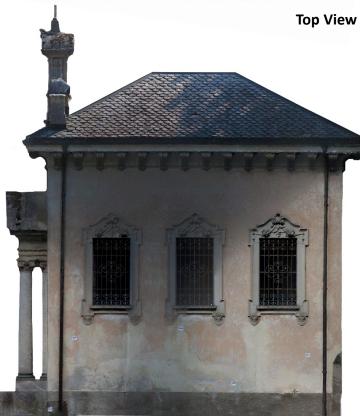
Side one Facade

- One camera
- Software
- Accuracy
- High resolution
- Cheap

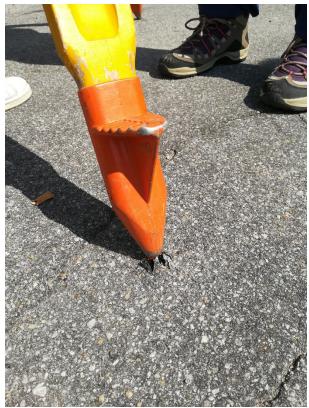
#### **STEP 1: Target position and station definition**

- Weather condition
- Assign markers

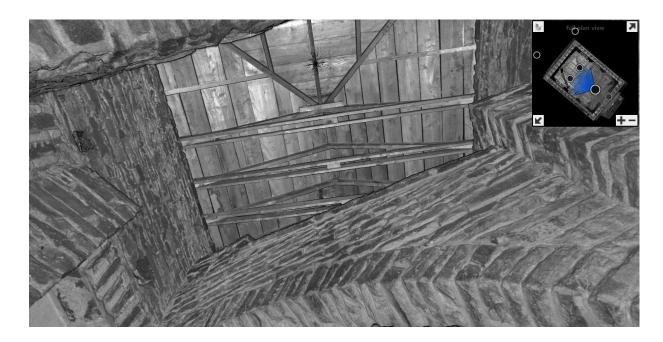
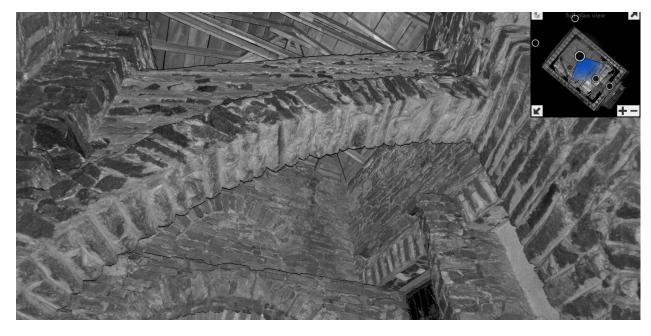
#### Problem 2

- Supporting information
- Complex geometry
- Rapid survey
